# PHYSICAL CONDITION SURVEY

LOUGH MELVIN HOLIDAY CENTRE  
2 DOOARD ROAD, GARRISON, BT93 4EN

JANUARY 2017

Oakleaf have undertaken a Physical Condition Survey of **Lough Melvin Holiday Centre** on behalf of Fermanagh & Omagh District Council.

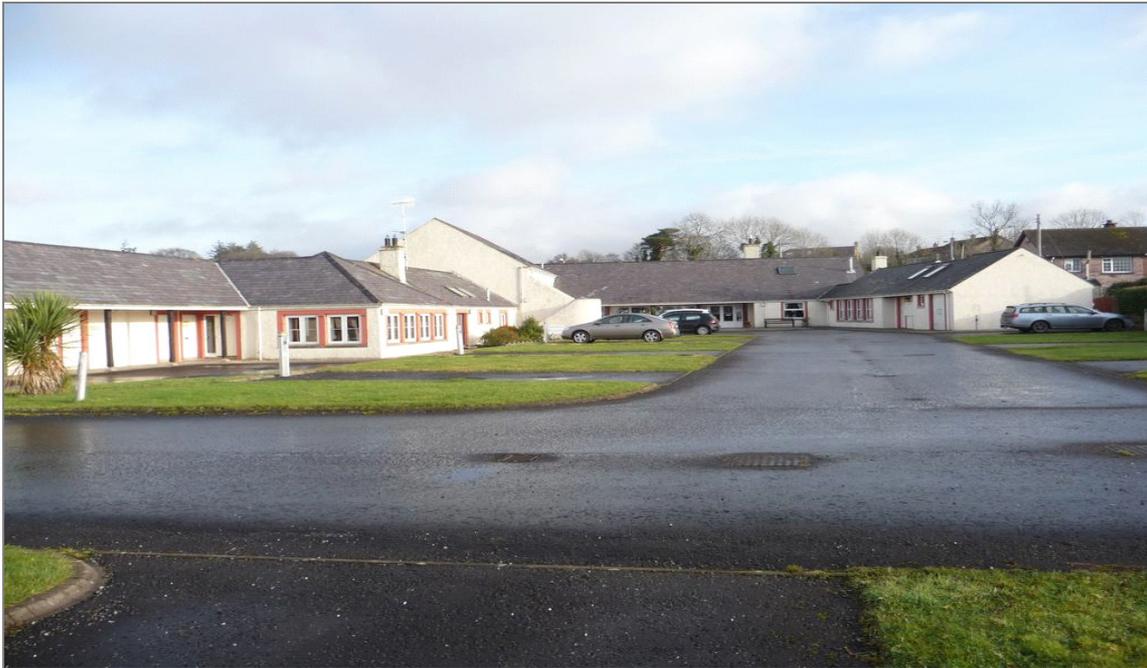
### 009 Lough Melvin Holiday Centre Block 001 - Main Block

**Type of Construction:** Two storey building having a general supporting structure comprised of, concrete block walls with a finish of render and stone chip and a steel frame for the restaurants. Roofs are pitched having a covering of slate.
